Building Survey

Property Address	7 Green Street, Huntingdon, Cambridgeshire, PE29 1EF
Client	Mr D Silke
Date of Inspection	04 March 2019

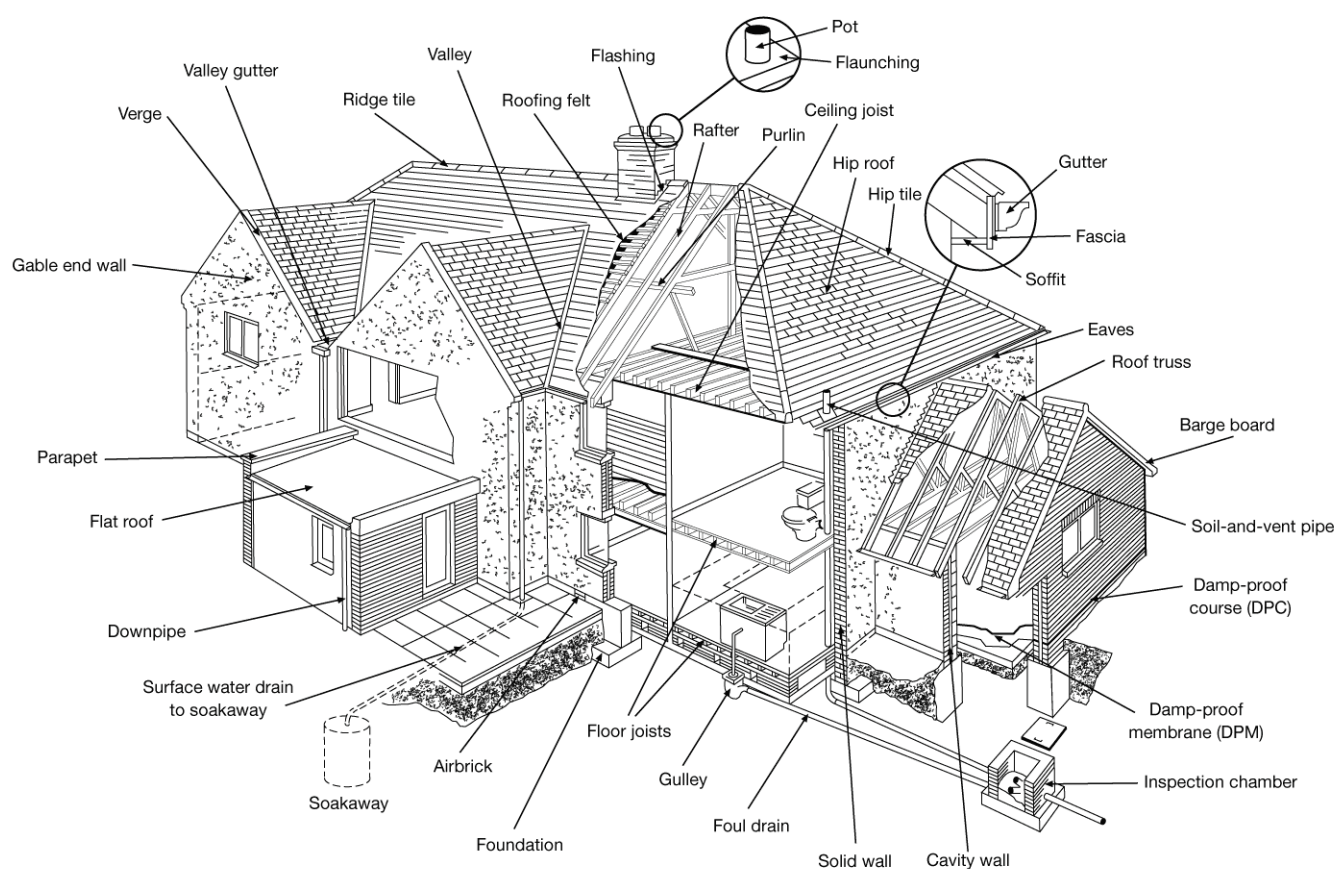
Typical house diagram

This diagram illustrates where you may find some of the building elements referred to in the report.
